The Road Inventory of Gavins Point National Fish Hatchery Yankton, SD

Prepared By: Federal Highway Administration Central Federal Lands Highway Division 06/2008

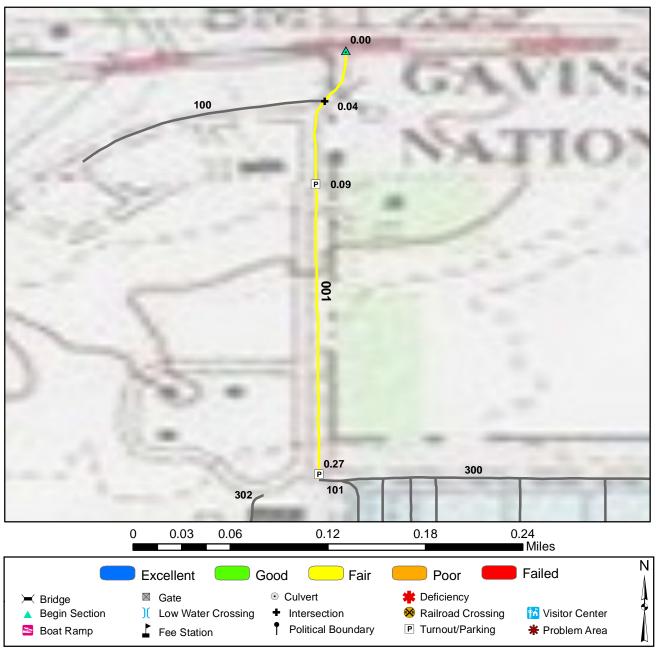
ROUTE: 010 Hatchery Access Road TOTAL LENGTH: 0.27 Miles

Section Number Section Length (miles) Inspection Date	001 0.27 5/17/2008		
Section Information			
Surface Type Number of Lanes Roadway Width (feet)	Asphalt 2 22		
Roadway Condition Information			
Condition	Fair		
Remaining Service Life (years)	10		
Cost Estimate CRV	\$29800 \$329500

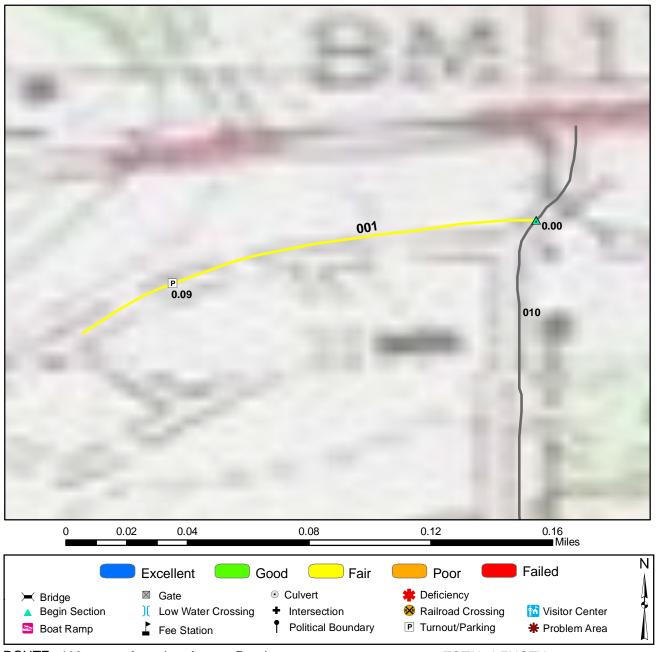
ROUTE: 100 Aquarium Access Road TOTAL LENGTH: 0.12 Miles

Section Number Section Length (miles) Inspection Date	001 0.12 5/17/2008		
Section Information			
Surface Type Number of Lanes Roadway Width (feet)	Asphalt 2 16		
Roadway Condition Information			
Condition	Fair		
Remaining Service Life (years)	10		
Cost Estimate CRV	\$13200 \$146400

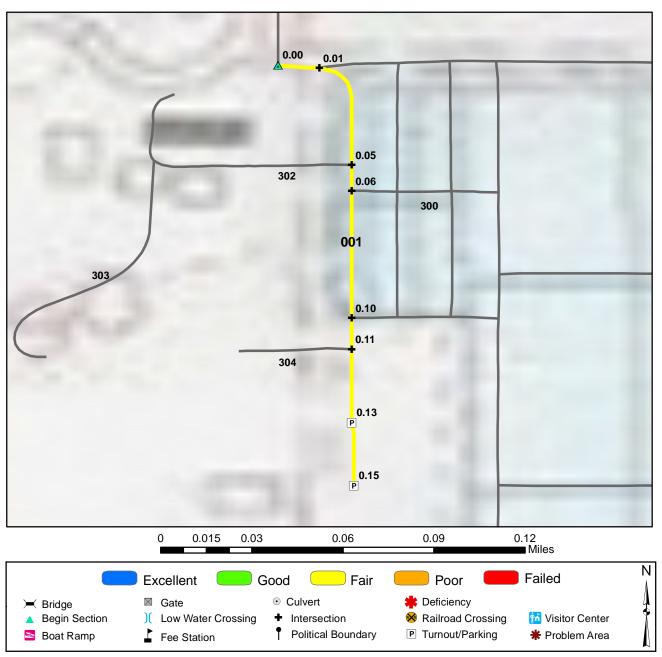
ROUTE: 101 Field Research Station Access Road TOTAL LENGTH: 0.15 Miles

Section Number Section Length (miles) Inspection Date	001 0.15 5/17/2008		
Section Information			
Surface Type Number of Lanes Roadway Width (feet)	Asphalt 1 14		
Roadway Condition Information			
Condition	Fair		
Remaining Service Life (years)	10		
Cost Estimate CRV	\$16500 \$183000

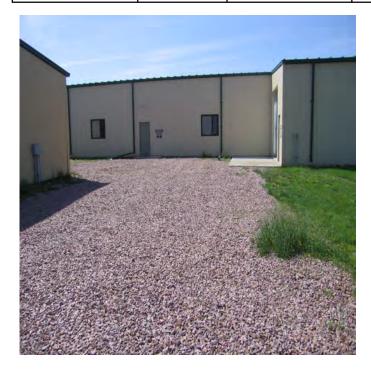
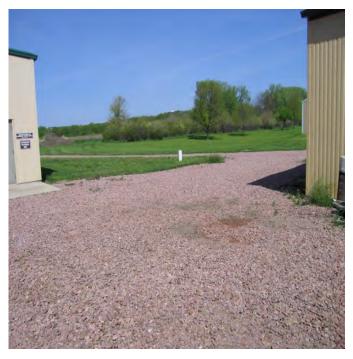
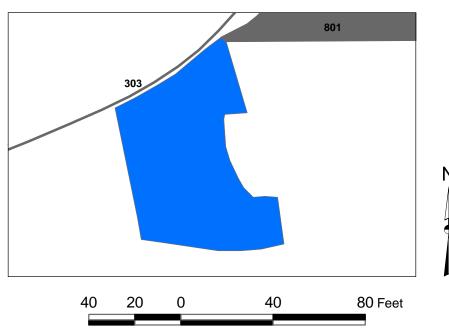
Gavins PointRoute 800: T/E Parking

Asset Number	Date Visited	Surface Type	Area (sq ft)	Condition	Cost to Improve
	5/17/2008	Gravel	2820	Excellent	\$0

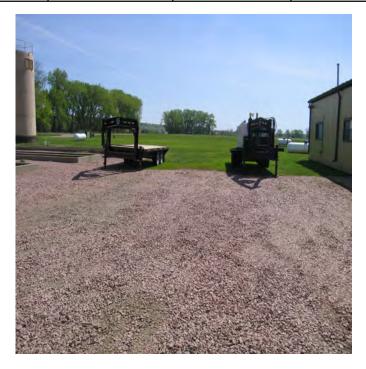
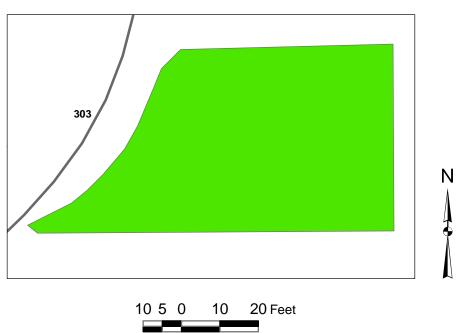
Gavins PointRoute 801: Endangered Species Building Parking

As	set Number	Date Visited	Surface Type	Area (sq ft)	Condition	Cost to Improve
		5/17/2008	Gravel	2435	Good	\$400

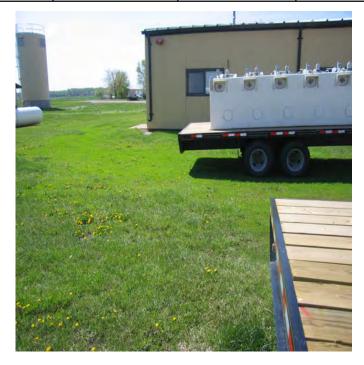
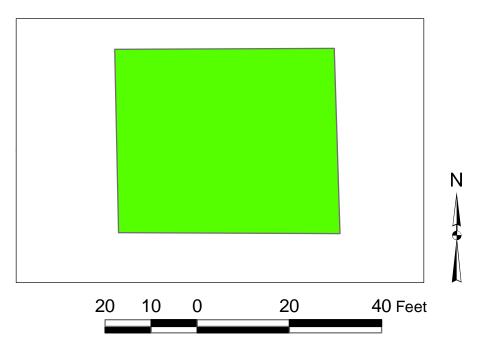
Gavins PointRoute 802: Endangered Species East Parking

Asset Number	Date Visited	Surface Type	Area (sq ft)	Condition	Cost to Improve
	5/17/2008	Native	1407	Good	\$200

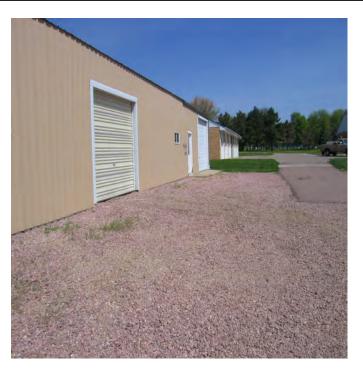
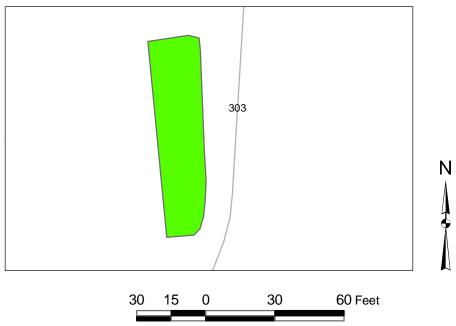
Gavins PointRoute 803: Sturgeon Building Parking

Asset Number	Date Visited	Surface Type	Area (sq ft)	Condition	Cost to Improve
	5/17/2008	Gravel	1238	Good	\$200

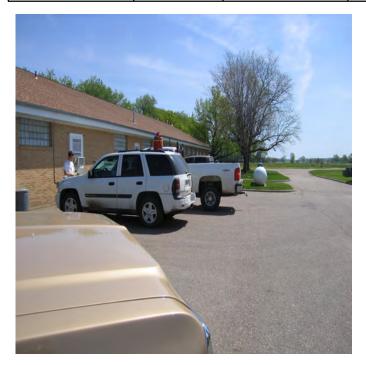
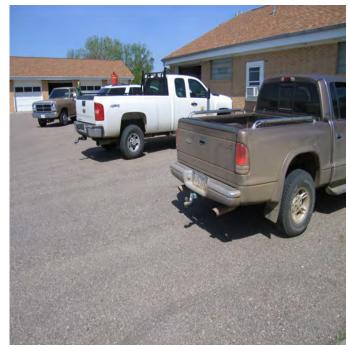
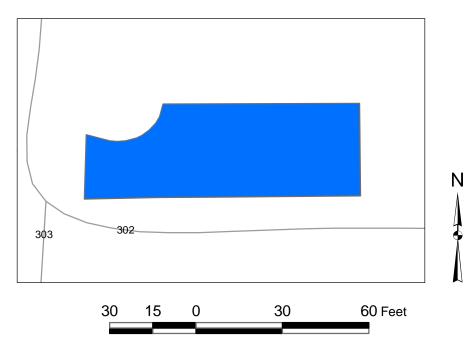
Gavins Point Route 804: Shop Parking South

Asset Number	set Number Date Visited		Area (sq ft)	Condition	Cost to Improve
10030117	5/17/2008	Asphalt	1892	Excellent	\$0

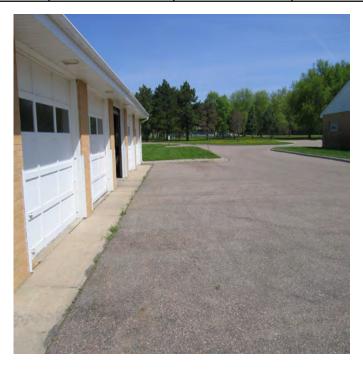
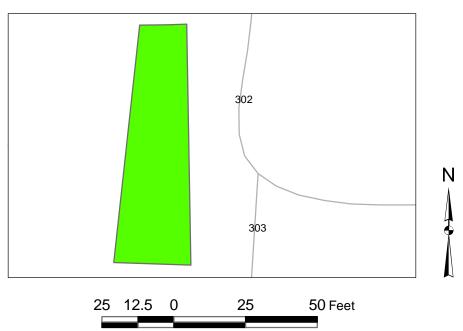
Gavins PointRoute 805: Shop Parking West

Asset Number	Date Visited	Surface Type	Area (sq ft)	Condition	Cost to Improve
10030117	5/17/2008	Asphalt	1142	Good	\$200

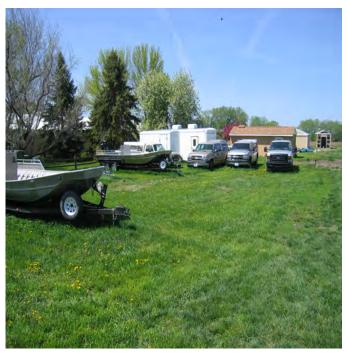
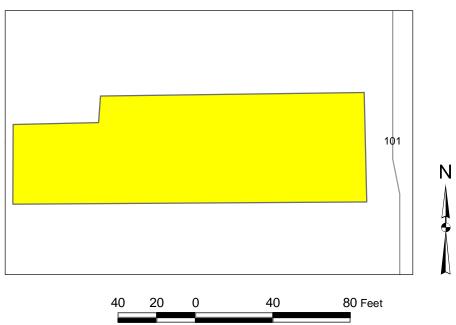
Gavins Point Route 806: Boat Parking Area

Asset Number	Date Visited	Surface Type	Area (sq ft)	Condition	Cost to Improve
	5/17/2008	Native	6704	Fair	\$1900

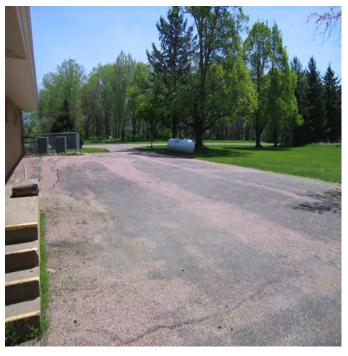
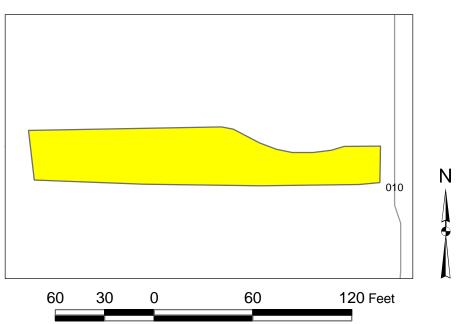
Gavins PointRoute 807: Aquarium Service Parking

Asset Number	Date Visited	Surface Type	Area (sq ft)	Condition	Cost to Improve
10030117	5/17/2008	Asphalt	4489	Fair	\$4000

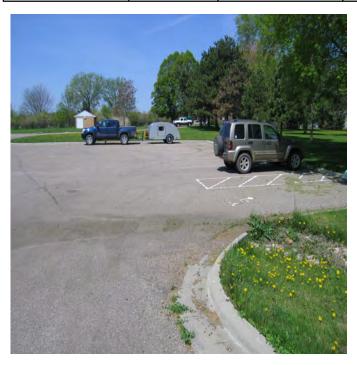
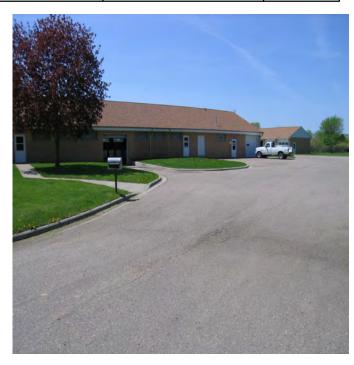
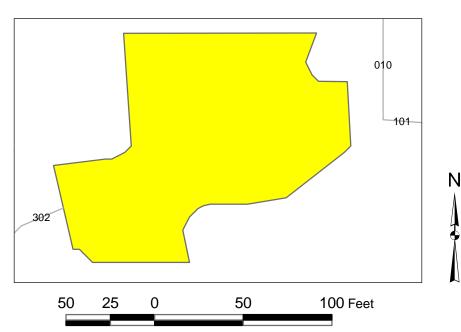
Gavins Point Route 900: Hatchery Headquarters Parking Area

Asset Number	Asset Number Date Visited		Area (sq ft)	Condition	Cost to Improve
10030117	5/17/2008	Asphalt	9746	Fair	\$8800

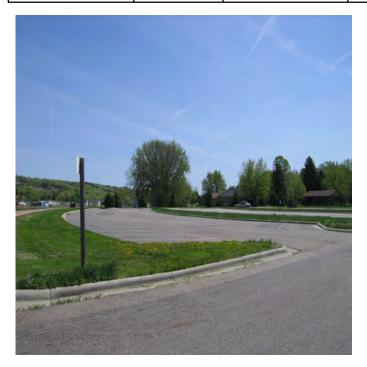
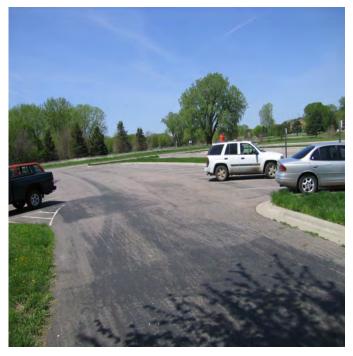
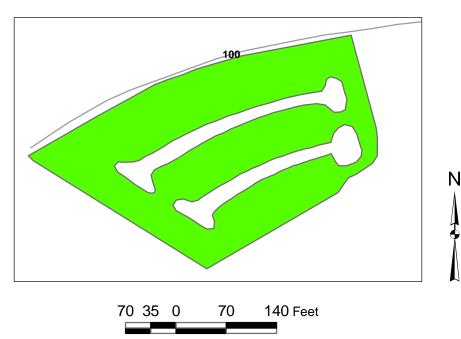
Gavins Point Route 901: Aquarium Parking Area

Asset Number	set Number Date Visited		Area (sq ft)	Condition	Cost to Improve
10051725	5/17/2008	Asphalt	0	Good	\$10800

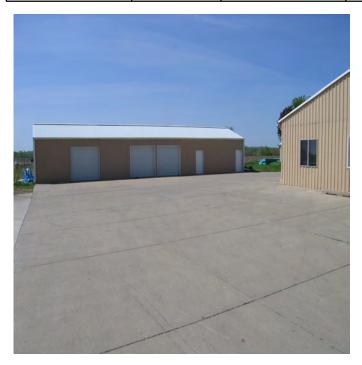
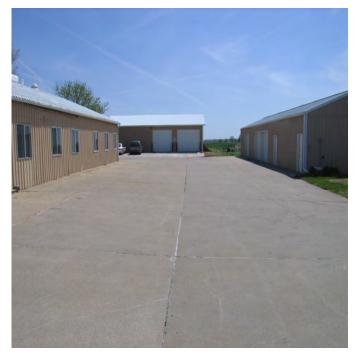
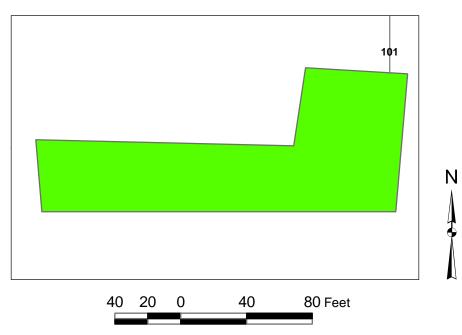
Gavins PointRoute 902: Field Research Station Parking Area

Asset Number	Date Visited	Surface Type	Area (sq ft)	Condition	Cost to Improve
10030117	5/17/2008	Concrete	8789	Good	\$1300
